MISCELLANEOUS PAPER S-77-9

PRELIMINARY INVESTIGATION OF GENERAL-PURPOSE MAT/PANEL MATERIALS

Soils and Pavements Laboratory
U. S. Army Engineer Waterways Experiment Station
P. O. Box 631, Vicksburg, Miss. 39180

May 1977

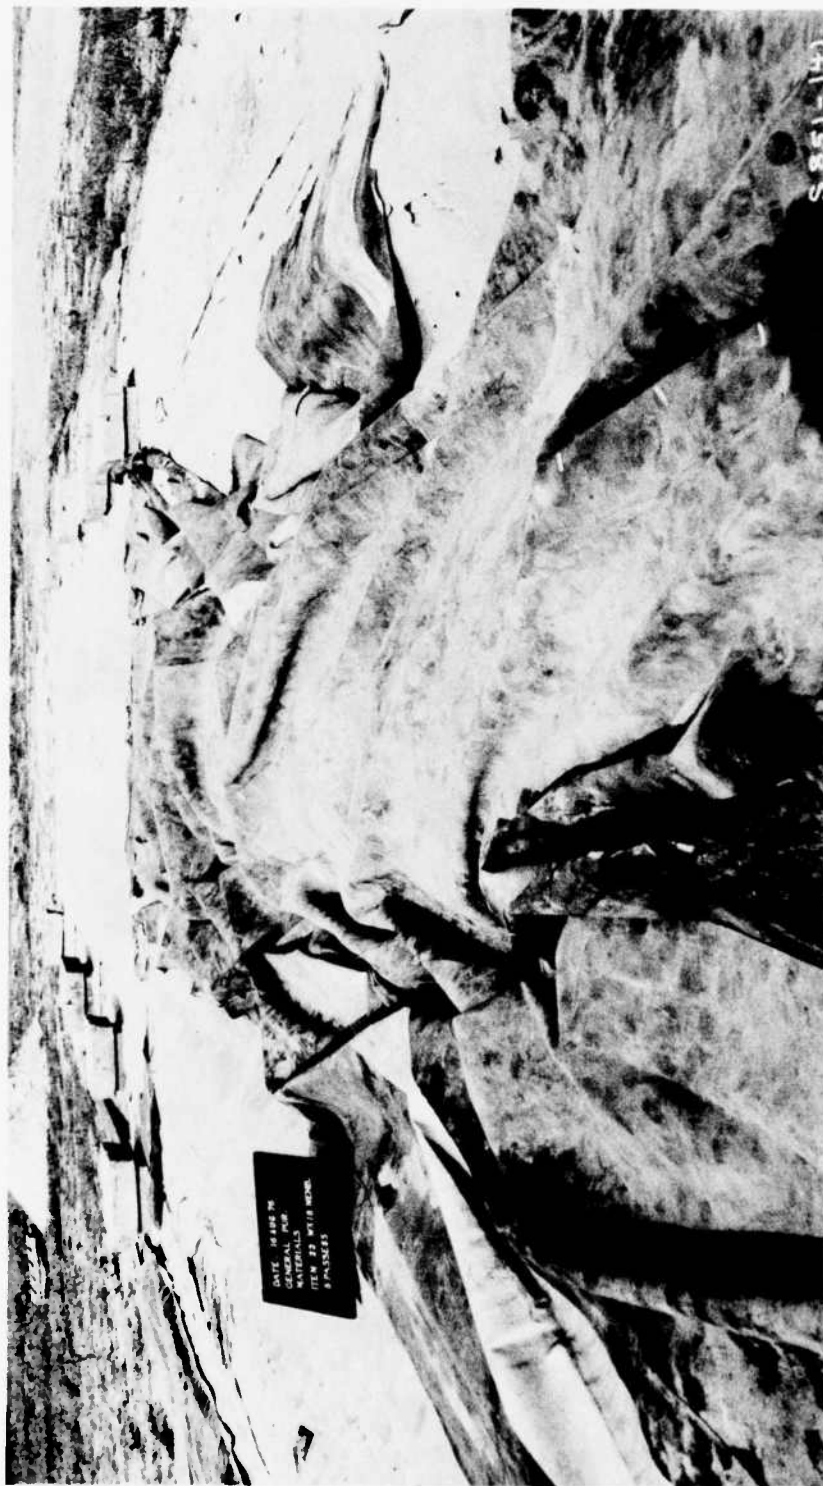
Photo 62. Item 23, WX18 membrane after 8 passes. Note wrinkles and membrane edge in wheel ruts
